**WATER DAMAGE AND MOULD ASSESSMENT
PORTABLE CLASSROOM FS 115 (Library)
MINISTIK SCHOOL**

Submitted to:
Elk Island Public Schools
683 Wye Road
Sherwood Park, AB. T8B 1N2

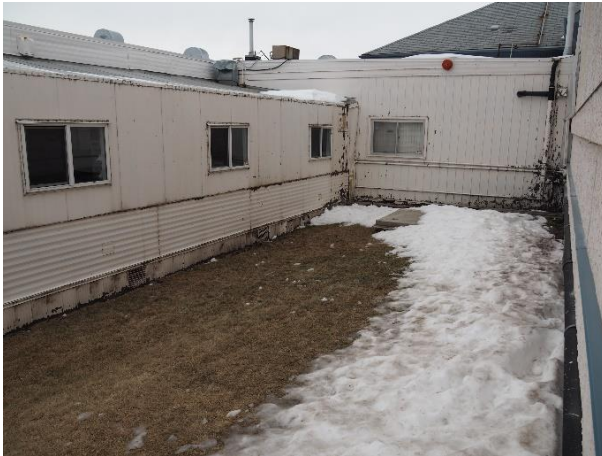
Photo #2:
Location of FS-115 left in relation to FS- 109 centre and the gymnasium right.

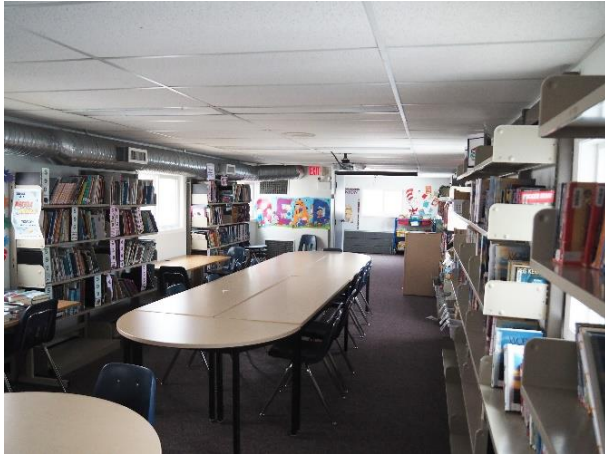
Photo #3:
Initial impression upon entering the Library is favourable with no obvious water damage.

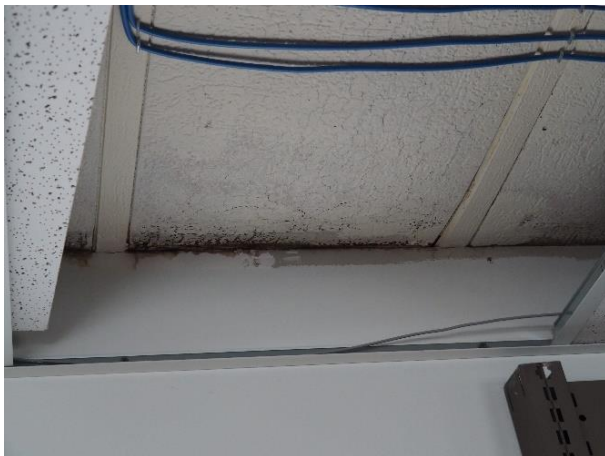
Photo #4: Above the new suspended ceiling tiles is the original cellulose ceiling with water staining.

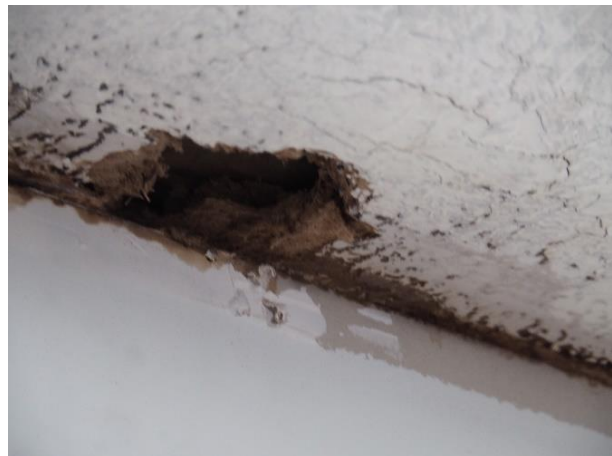
Photo #5: Close up showing location of sample 4468.01 with Fungal mycelia indicating mould amplification.

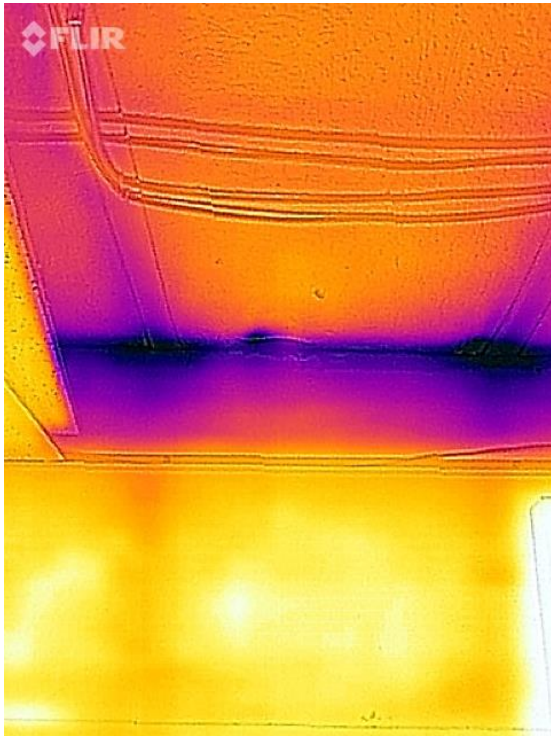
Photo #6:
Thermography at the wall to ceiling joint showing cool spots in blue potential condensation areas that coincide with the water damage and mould growth shown in photos 4 and 5.

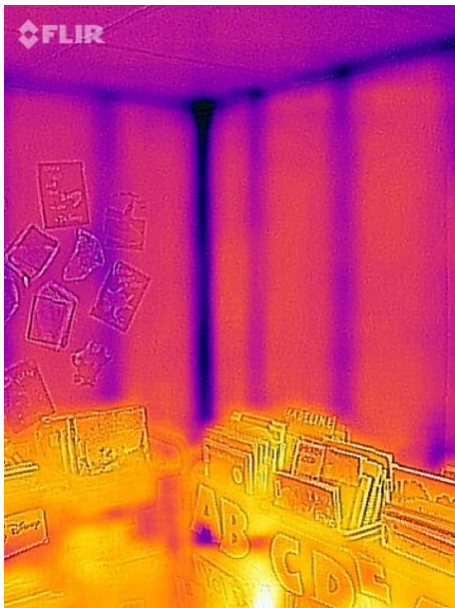
Photo #7: Northeast corner showing cold transfer through framing

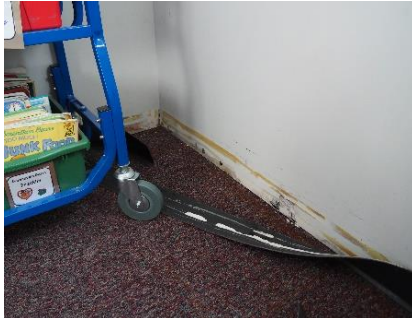
Photo #9: Northeast corner with baseboard peeled back.

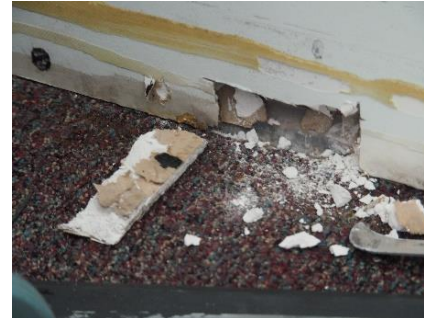
Photo #11: *Chaetomium* sp. On the reverse side of the drywall.

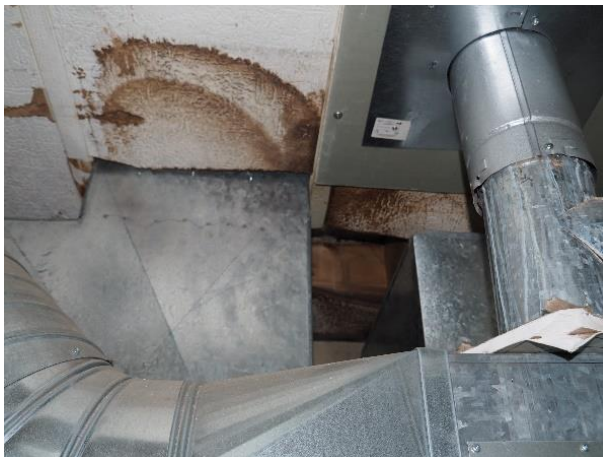
Photo # 12: Water damaged original ceiling in the mechanical room of FS-115.

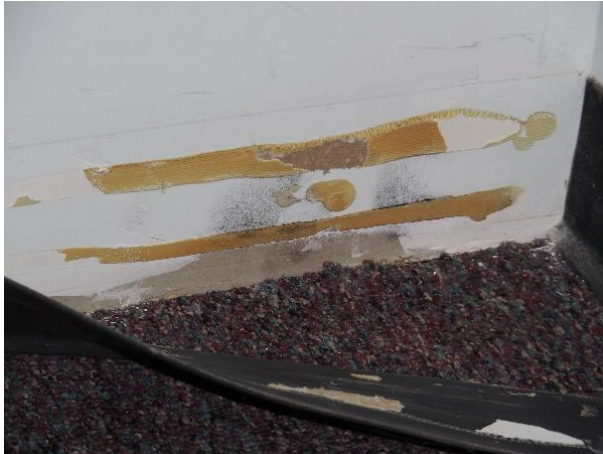
Photo # 13: Mould growth behind the baseboards on the west wall under the window adjacent to the air return grille.
